CITY OF BALTIMORE SMOKE TESTING OBSERVATION SUMMARY LOW LEVEL SEWERSHED

BALTIMORE CITY PROJECT 1029 REI/DRAYCO

Unique Test ID: 601 Date: 08/26/2008 Basin: LL - 44 Manhole ID: S17I__015MH Defect No: OB01 Supervisor: E.R. Crew: 04 Dye Test Recommended: N

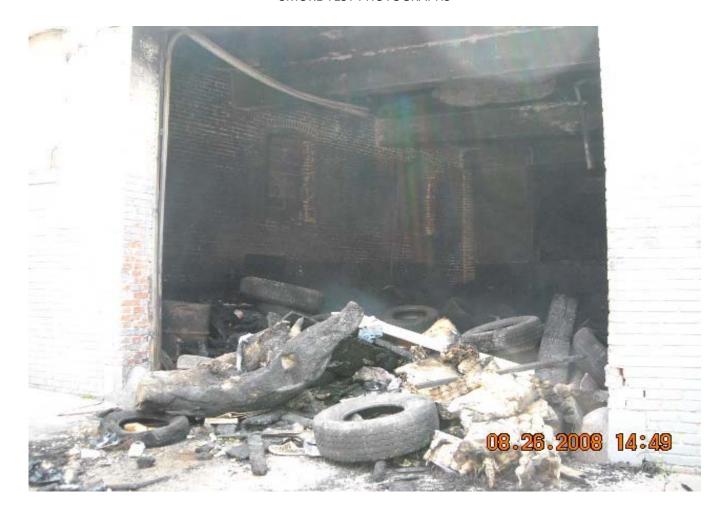
Photograph No: OB01-01 Filename: 1029-601_OB01-01.jpg

Location: 53 S. CATHERINE ST.

Source Type: 09 Building Interior Sector: 02 Private

Location: 14 Other Severity: 03 Moderate Drainage Area: 0

Comments: MODERATE AMOUNTS OF SMOKE ARE COMING FROM THE ABANDONED BUILDING AT THIS

ADDRESS.
